# UNDERWATER BRIDGE INSPECTION REPORT

STRUCTURE NO. 70002  
CSAH 101  
OVER  
THE MINNESOTA RIVER  
DISTRICT M - SCOTT COUNTY

PREPARED FOR THE  
MINNESOTA DEPARTMENT OF TRANSPORTATION  
BY  
COLLINS ENGINEERS, INC.  
JOB NO. 5221

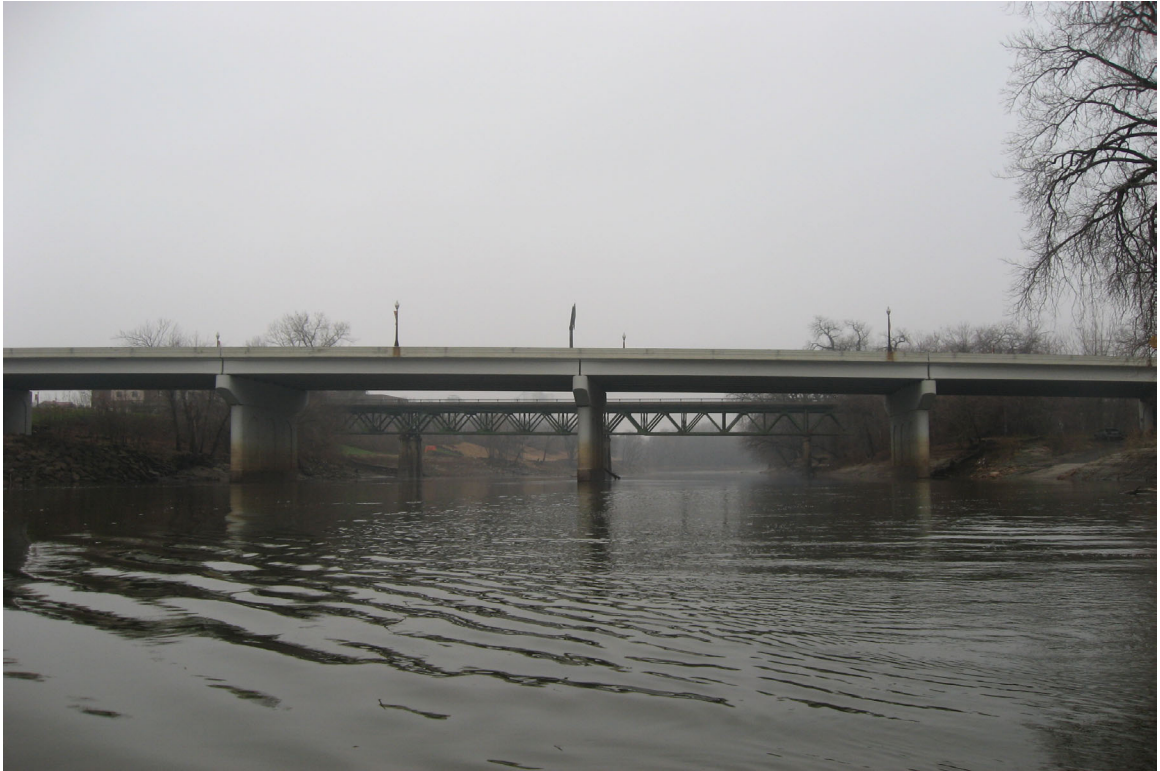
Photograph 1. Overall View of the Structure, Looking West.

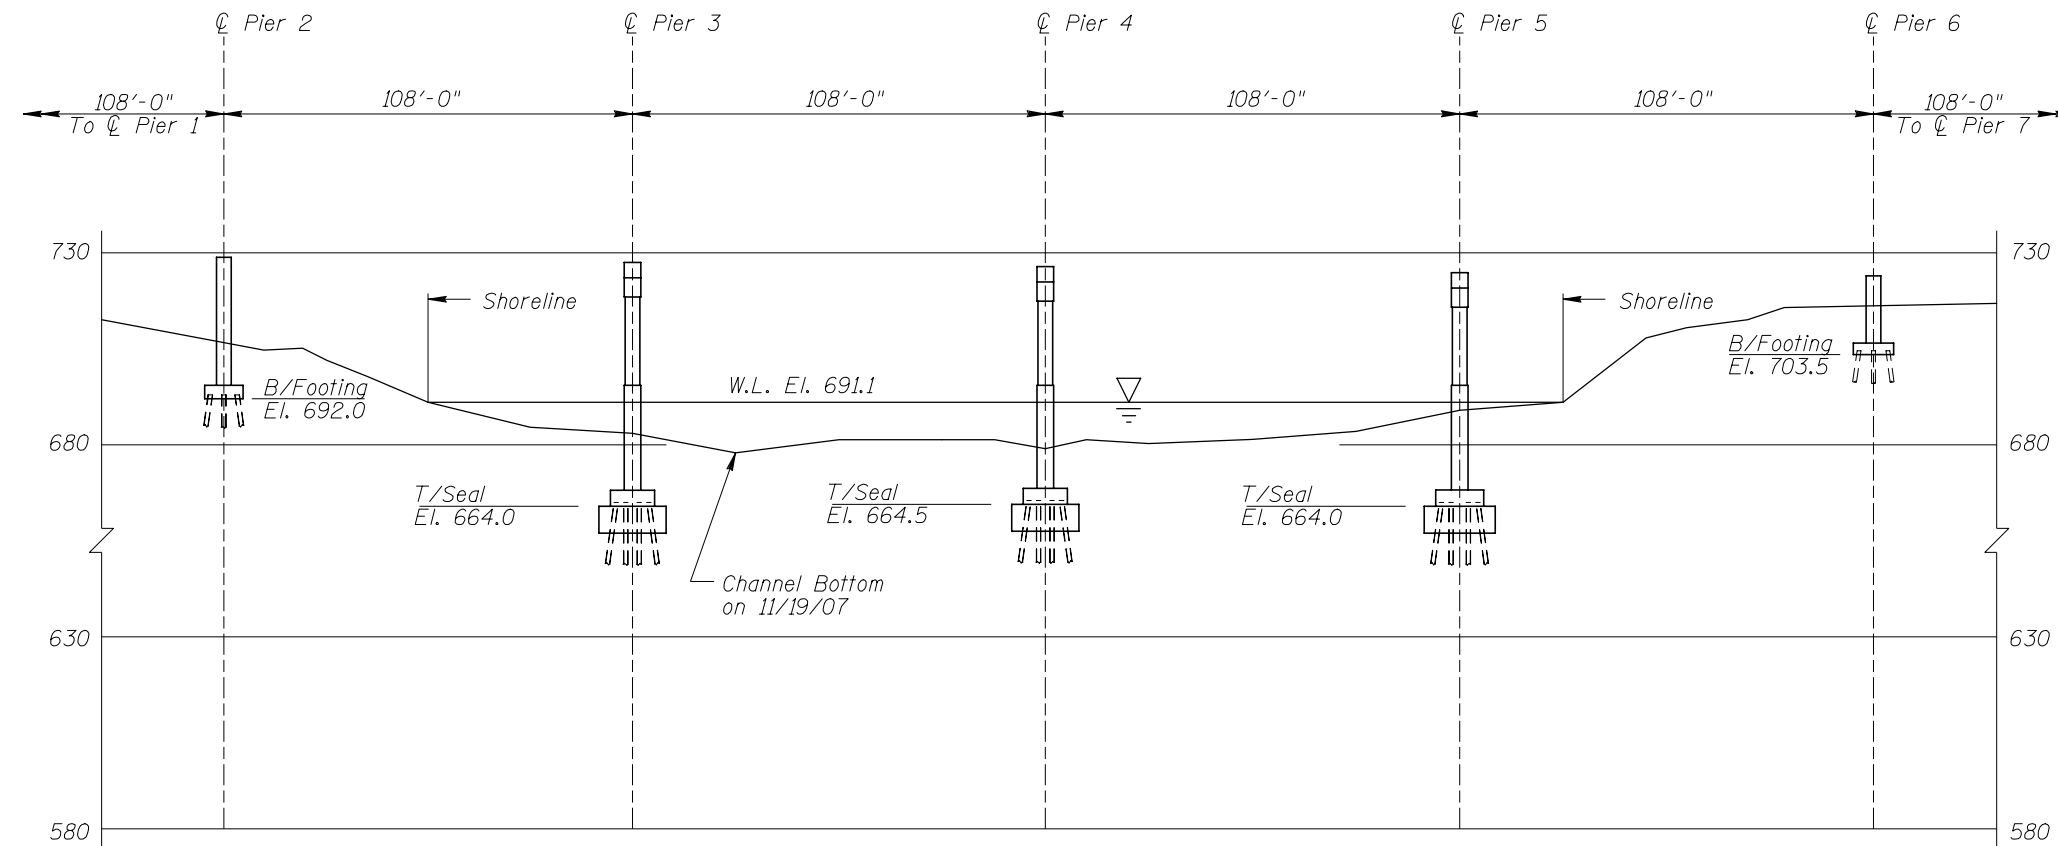
UPSTREAM FASCIA PROFILE

- Random vertical cracks were observed from the top of the shaft ledge to the channel bottom with efflorescence. There were typically two cracks on each pier at about the third points with 1/8 inch maximum width.

- Moderate to heavy accumulation of timber debris consisting of logs and branches 12 to 15 inches in diameter and smaller was observed along the south face, around the upstream nose and to about the midpoint on the north face of Pier 3 extending from the waterline to the channel bottom.

- The channel bottom of Pier 4 consisted of silt, gravel, and clay with up to 6 inches of penetration.
- A moderate accumulation of timber debris consisting of 12 inch diameter and smaller logs and branches was observed from the upstream nose to the upstream quarter points on both sides of Pier 4.

- A scour depression 5 feet in radius by 2 feet deep was observed at the upstream end of Pier 4.
- The channel bottom of Pier 5 consisted of clay and silt with 2 to 3 inches of probe rod penetration and also stones 6 inches in diameter located at the upstream end.

Monitor the timber debris at the piers, and if found to be increasing in the future, removal operations may become warranted.
